# Containment and disposal of asbestos contaminated dust and debris arising from fire damaged buildings

## Guidance note

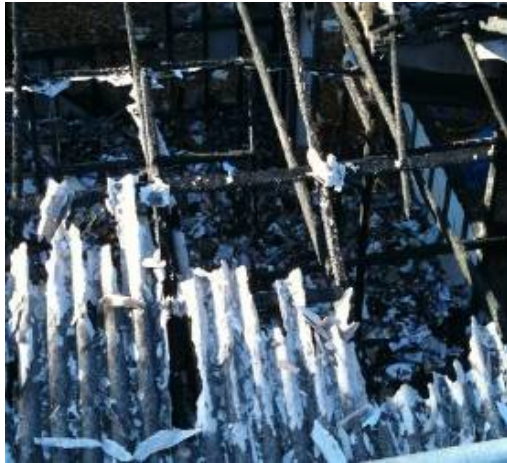
**Photo 1:** The high temperature of the fire has caused a spalling effect to the roof sheeting

When exposed to fire and high temperatures, the ACM products may suddenly crack and break, causing the product to degrade as a result of loss of moisture from the high temperature. In these circumstances, the ACM products may 'explode' or spall into smaller pieces. Spalling of asbestos cement products can cause the release of fibres, but again these concentrations are well below typical background levels, and typically spalling only occurs in the early stages of the fire.<sup>6,7</sup> The most significant effect of spalling is the distribution of debris, often many meters from the original material and potentially beyond the boundary of the property or site.

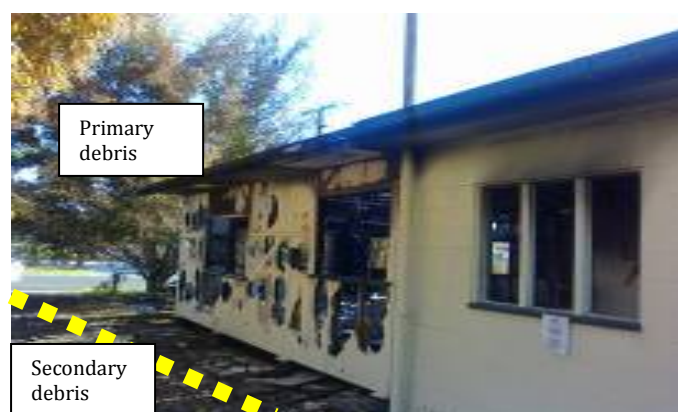
**Photo 2:** This single story fibro clad house was extensively damaged by fire. Confirmed asbestos containing material, from the roof, soffits, external and internal walls was found both internal to the structure and in a radius of approximately 20 metres from the structure.

These zones should be carefully inspected for the presence of ACD. Affected areas should be clearly marked out. Photo 2 illustrates the primary and secondary debris zones.

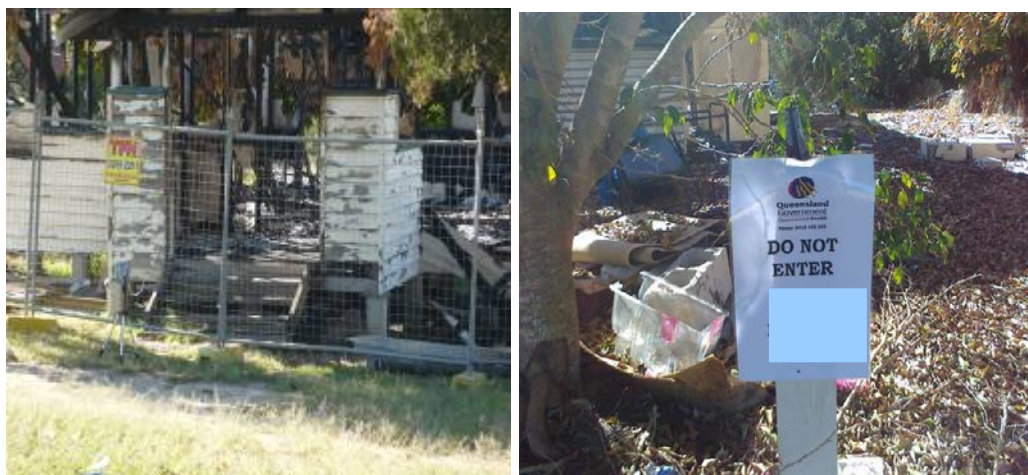
**Photos 3 and 4:** Examples of barriers and signage that may be required if there is a need to prevent people from entering the fire damaged property

- Putting up warning signs cautioning people from entering the boundaries of the property containing the fire damaged building. An existing fence around the boundary of the property may be used to affix the required signage and aid in preventing persons from entering the debris area.
- If signage is not sufficient to keep people out of the debris zone consideration should be given to erecting a fence, which can include temporary fencing.

Photos 3 and 4 illustrate the above.

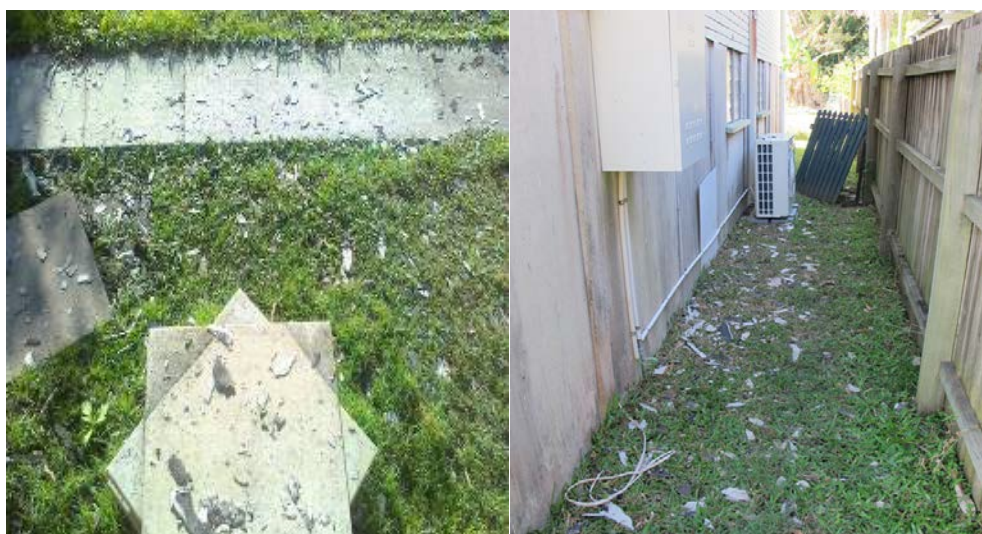
**Photos 5 and 6:** Residue showing typical visible soil surface debris

It is important to note asbestos soil contamination from fire events is confined to soil surface impacts only. Therefore, there is no requirement to excavate the soil in the secondary debris zone. All visible ACM should be removed. Photos 5 and 6 illustrate typically visible debris on the ground in the secondary debris zone following a fire.

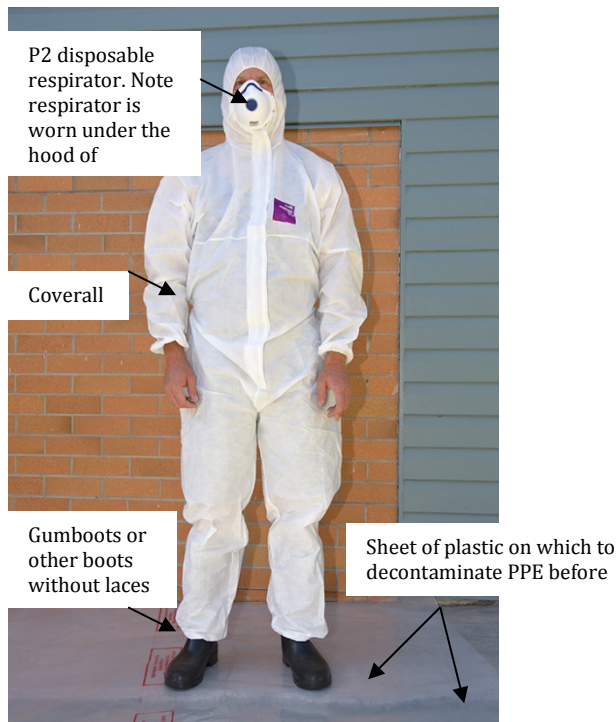
**Photo 7:** PPE that should be worn during clean-up of debris

**Personal protective equipment (PPE)** Persons engaged in the containment and disposal of fire damaged ACM should use a range of PPE as outlined below.

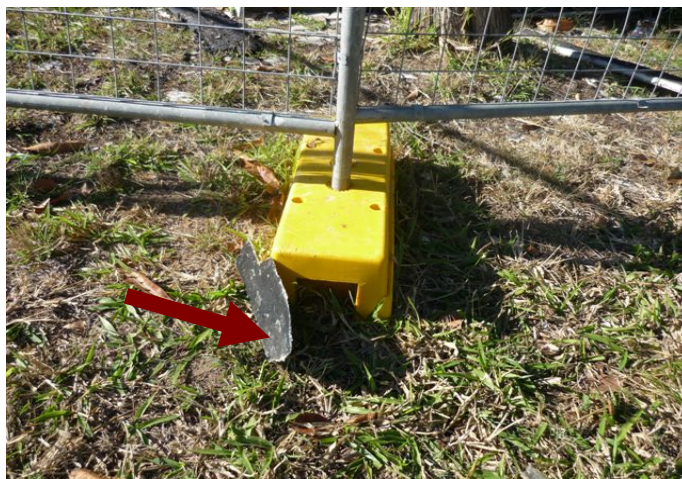
**Photo 8:** delaminated thin pieces of ACM should be shovelled up along with soil immediately below

**For ACM debris on the lawn**– Put on a P2 respirator and coveralls. Wet the debris with light water pressure from a garden hose or spray bottle. Large pieces can be picked up and placed in a sturdy plastic bag or container<sup>15</sup>. Very small pieces and/or significantly damaged pieces can be shovelled up along with the soil immediately below, and placed into the bag or container. Photo 8 shows a picture of significantly fire damaged ACM that should be shovelled up along with the soil immediately below.

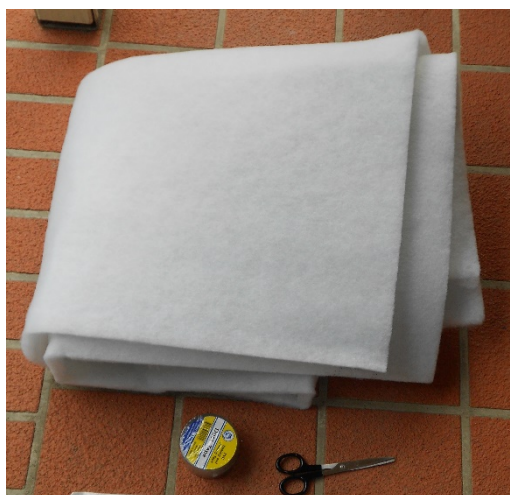
**Photo 9:** Filter medium

Geofabric™<sup>16</sup>, or a filter sock filled with fine sand, over the open end of the down pipe to collect residue that may be dislodged during rain events. This also prepares the roofs and gutters to be washed down by a garden hose applied at low pressure. The collected residue from the roof will be contained in the filter medium and must be disposed of as asbestos waste once the work is completed. Photo 9 illustrates an example of a filter medium. Photo 10 illustrates debris on a neighbouring roof.

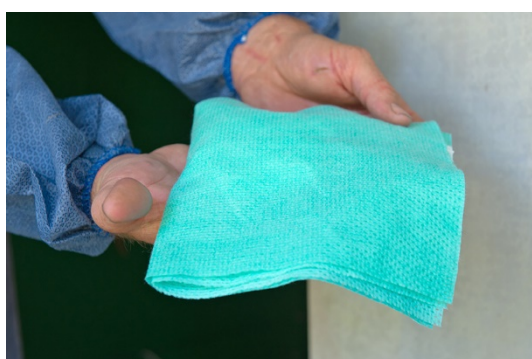
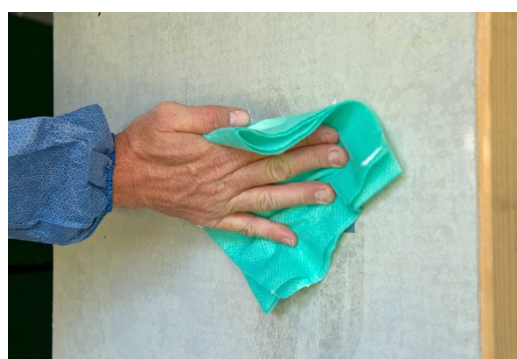
**Photo 11:** wet wiping of hard surfaces

A wetted wipe

A wetted wipe being used on a surface once only

**For visible debris on hard surfaces such as window and door sills, ledges** - Put on a P2 respirator and disposable coveralls in preparation for wet wiping visible dust and debris off hard surfaces. Wet wiping involves using a moistened cloth to wipe dust from a surface, as shown in photo 11. To ensure the surface of the wipe is used only once, the wipe is folded after each wipe so as to expose a clean wipe surface. When folding of the wipe cannot expose any further clean wipe surfaces, the wipe is disposed of as asbestos waste.

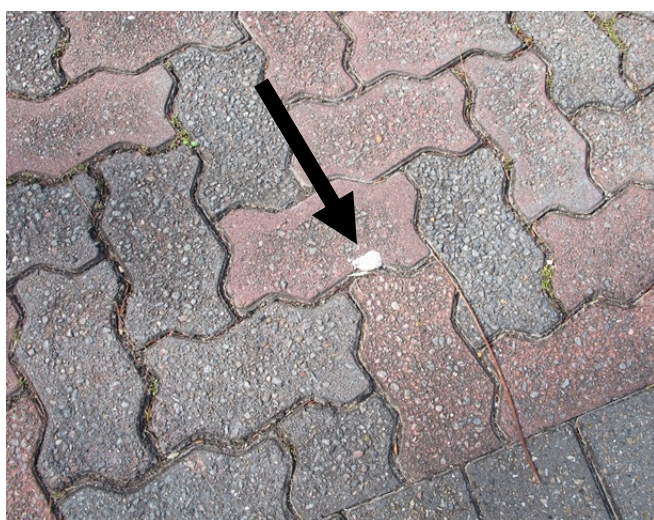
**Photo 12:** small piece of debris on paved pathway

**If there is a need to wash down driveways, concrete paths etc,** put on a P2 respirator and coveralls, and using a post-hole shovel, dig an earthen channel to the shovel width and the full length of driveway and or path. Then lay some filter medium in the channel/s. Using water at low pressure from a garden hose, wash the debris into the channel so the debris collects in the filter medium. Once the surfaces are visibly clean, carefully roll up the filter medium and dispose of as asbestos waste. Replace the soil in the channel. This is illustrated in Diagram 2. Photo 12 illustrates debris on a paved pathway, and photo 13 illustrates the filter medium taped in place.

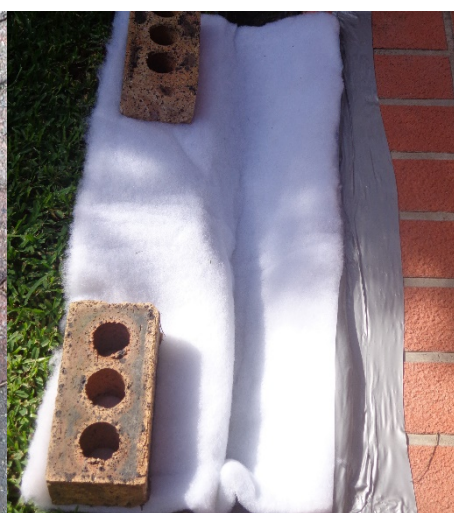
**Photo 13:** Filter medium in a channel in place in readiness to capture residue and filter out the water.

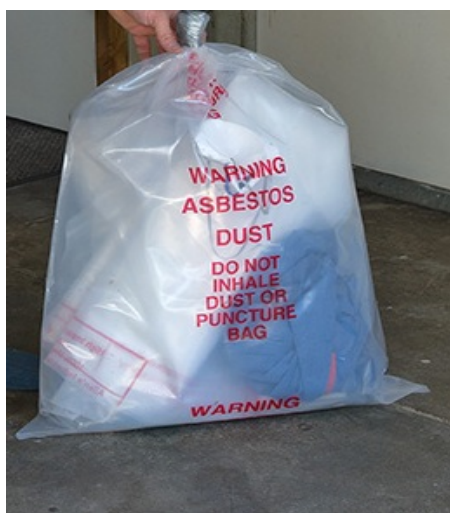
**Photo 14:** ACM debris correctly sealed in an approved bag.

Before the debris is placed in the bags you must first ensure that it has been wetted down. Once the bag is one third full, twist the remainder of the bag to form a long section which is then ducted taped to secure the bag. Place this bag inside another bag. This is called double bagging. This is illustrated in photo 14. Alternatively, place the single bag in a polyethylene<sup>17</sup> lined bin or container and then seal the lid on completion. The waste is then taken to an approved waste disposal site.

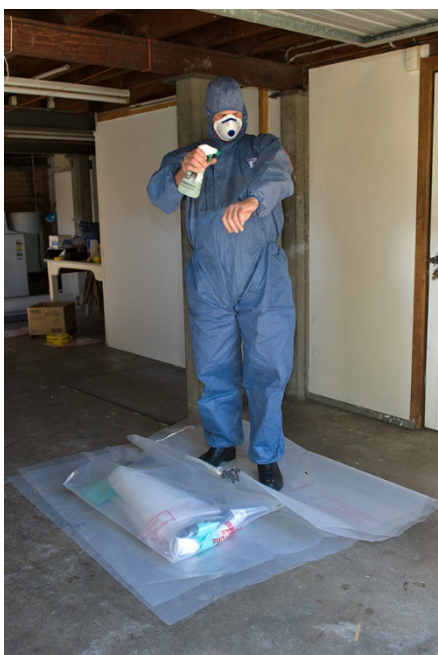
Step 1: Standing on a plastic sheet (a decontamination facility), use an atomiser bottle of water to wet the coveralls.

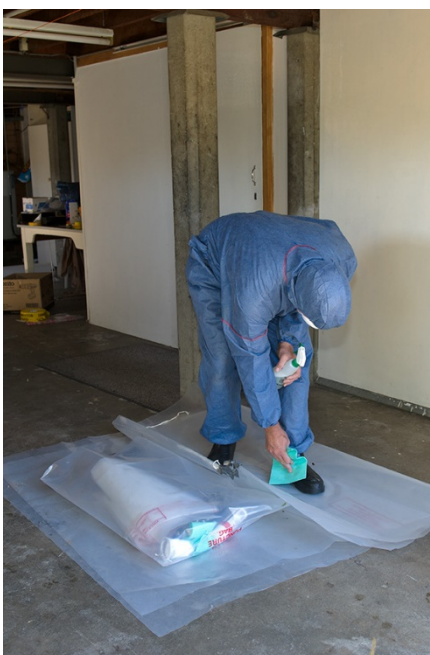
Step 2: Wet wipe boots

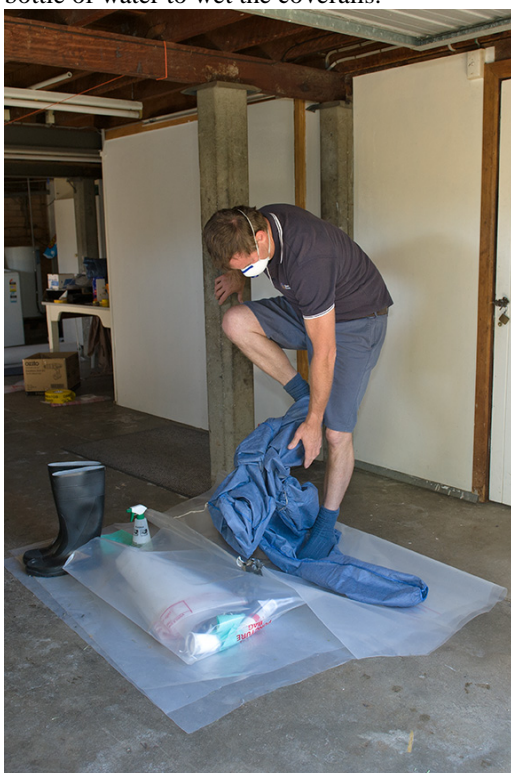
Step 3: Remove the moistened coveralls

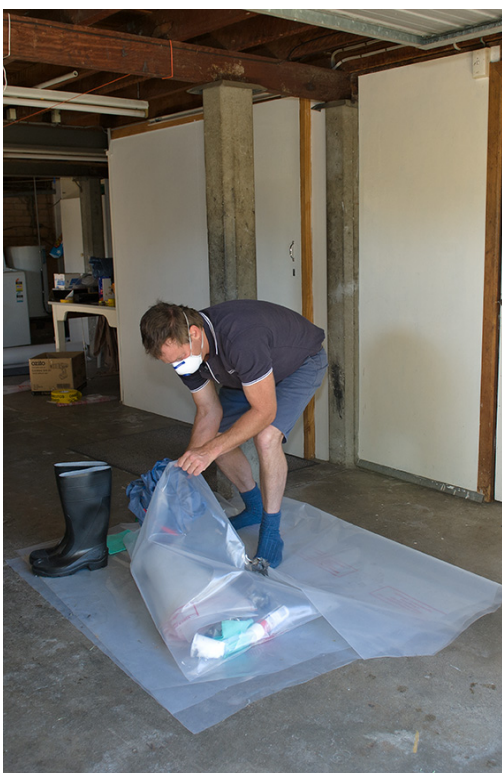
Step 4: Place the coveralls and wipes in an approved waste bag.

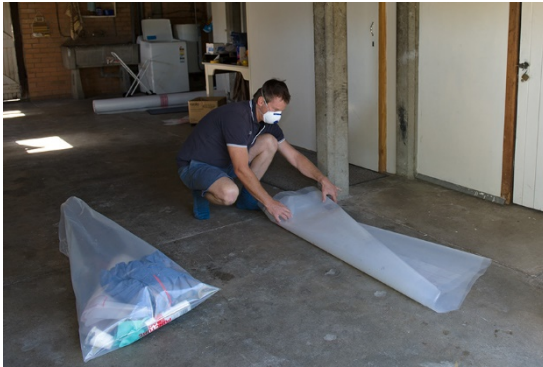
Step 5: Fold up the plastic sheet.

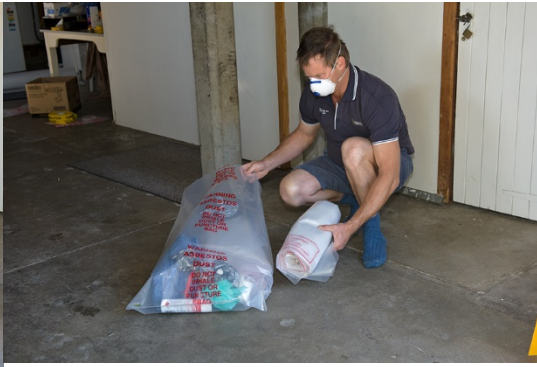
Step 6: Place the folded sheet in the waste bag.

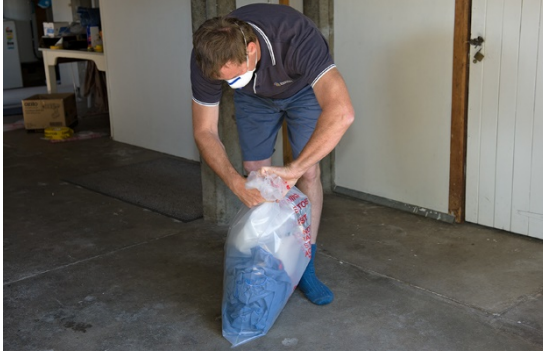
Step 7: Tape the first bag shut

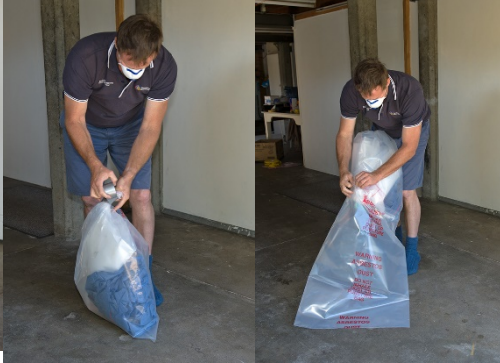
Step 8: Place the first bag inside a second bag.  
Now remove disposable respirator and place in the second bag.

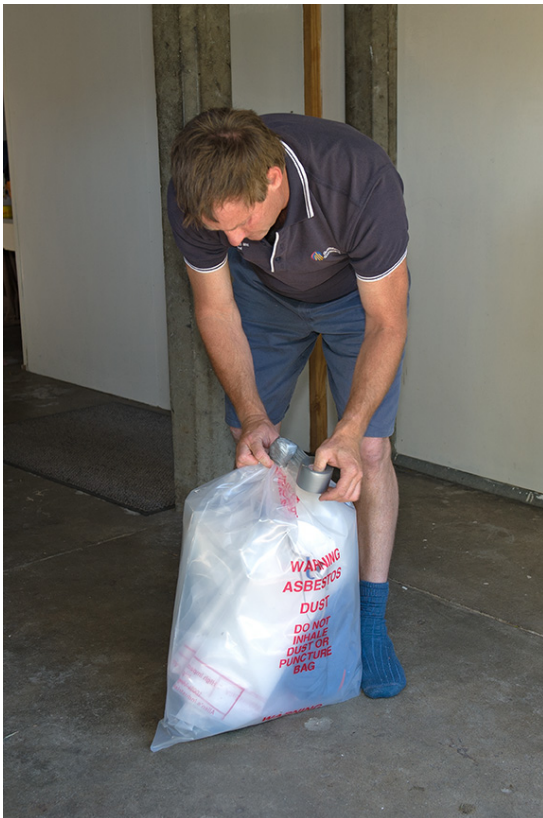
Step 9: Seal the second bag

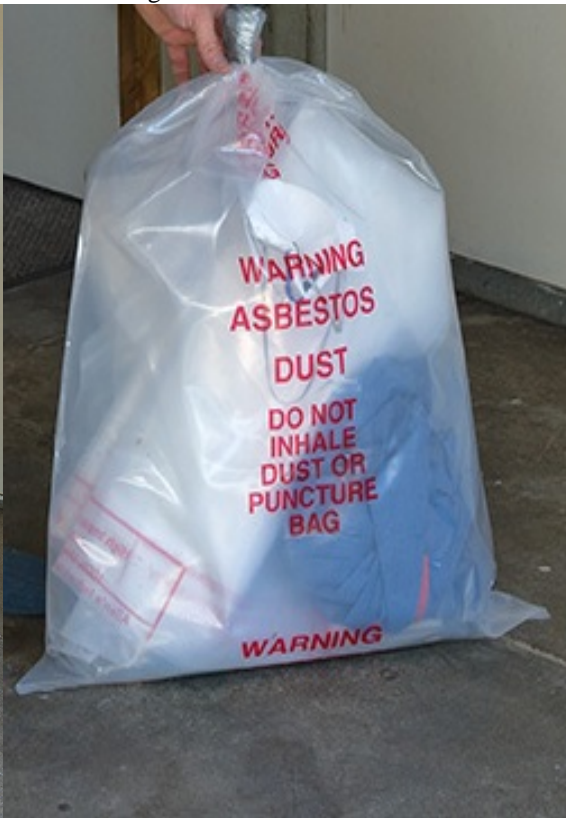
Step 10: All waste properly sealed in the approved bag.

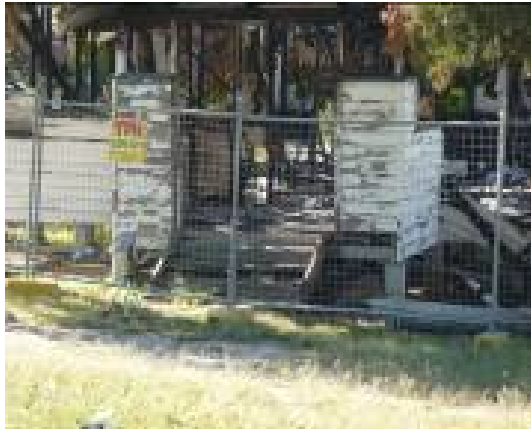
Pictures of the fire damaged houses at which airborne fibre measurements were conducted

(a) 5 x sampling filters connected to pumps were located within the damaged buildings, and at approximately five, ten and 20 metres away from the damaged buildings, on the four fence boundaries of the properties, and upwind and downwind. The day of sampling was sunny, with a light breeze blowing. The debris was dry. Fibre sampling and analysis was conducted in accordance with the *Guidance Note on the Membrane Filter Method for estimating Airborne Asbestos Fibres 2<sup>nd</sup> Edition [NOHSH 3003 (2005)]*.

Fibre concentrations were found to be < 0.01 fibres per millilitre of air, which is below the limit of detection of the measurement procedure. To put this into a risk content, the occupational exposure standard for asbestos fibres is 0.1 fibres per millilitre, and the lowest action level for reviewing risk management procedures under workplace health and safety legislation is 0.01 fibres per millilitre of air. Therefore the likelihood of asbestos fibres being blown off-site in measurable concentrations likely to cause exposure significant enough to cause asbestos related disease is extremely low.

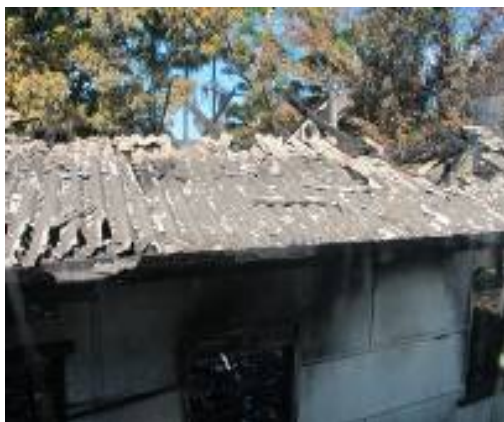
(b) 5 x sampling filters connected to pumps were located within the damaged buildings, and at approximately five, ten and 20 metres away from the damaged building, on the four fence boundaries of the properties, and upwind and downwind. The day of sampling was sunny, with a strong breeze blowing. The debris was dry. Fibre sampling and analysis was conducted in accordance with the Guidance Note on the *Membrane Filter Method for estimating Airborne Asbestos Fibres 2<sup>nd</sup> Edition [NOHSH 3003 (2005)]*.

Sampling was conducted for approximately four hours at a pump flow rate of 2.0 litres/minute.

Fibre concentrations were found to be < 0.01 fibres per millilitre of air, which is below the limit of detection of the measurement procedure. To put this into a risk content, the occupational exposure standard for asbestos fibres is 0.1 fibres per millilitre, and the lowest action level for reviewing risk management procedures under workplace health and safety legislation is 0.01 fibres per millilitre of air. Therefore the likelihood of asbestos fibres being blown off-site in measurable concentrations likely to cause exposure significant enough to cause asbestos related disease is extremely low.

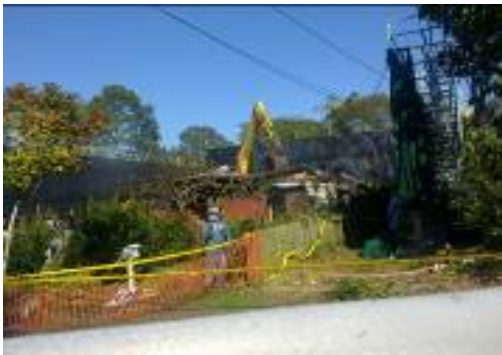
Sampling for airborne asbestos fibres was conducted over three days during demolition of a fire damaged house. 18 x sampling filters connected to pumps were located within the property, within neighbouring properties, and on the property boundaries. During the three days of sampling the weather was sunny, with a light breeze blowing. Methods to minimise dust generation were implemented and included the debris being kept damp during the demolition process and dust barriers erected along all boundaries of the property. Fibre sampling and

Water spraying during machinery demolition

Fibre concentrations were found to be < 0.01 fibres per millilitre of air, which is below the limit of detection of the measurement procedure. To put this into a risk content, the occupational exposure standard for asbestos fibres is 0.1 fibres per millilitre, and the lowest action level for reviewing risk management procedures under workplace health and safety legislation is 0.01 fibres per millilitre of air. Therefore the likelihood of asbestos

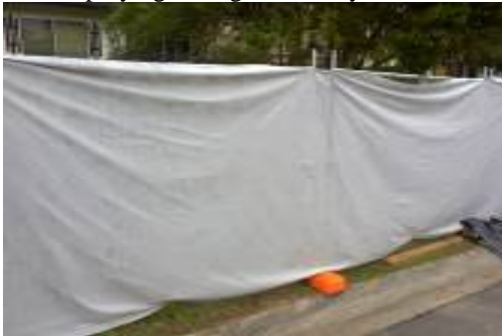
Dust barriers on boundaries of the demolition area

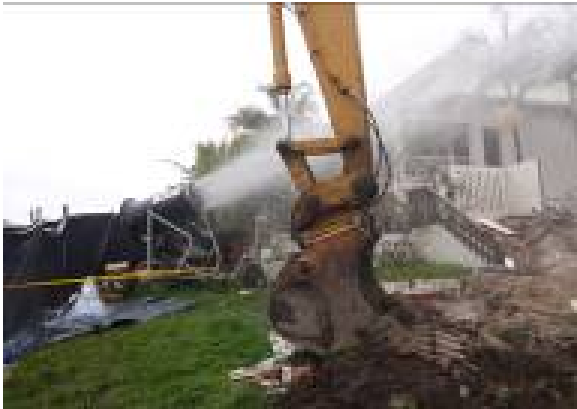
Water mist spraying during machinery demolition
